## TEST NOTE

<b>To:</b> Dr. Mike Taylor Technical Manager Research and Technology	<b>From:</b> R. G. Batchelor Senior Technologist Research and Technology
<b>Test Note Number:</b> IS-006-09 <b>Date:</b> 18 <sup>th</sup> February, 2009	
<b>Title:</b> Commissioning Report on the Detonator Gallery RL 22G. <b>Material:</b> Carrick Detonator Incendive Testing. <b>Source:</b> Research and Technology Department.	
<b>Authorised for release:</b> Dr. Mike Taylor Technical Manager	
<b>Signature:</b>

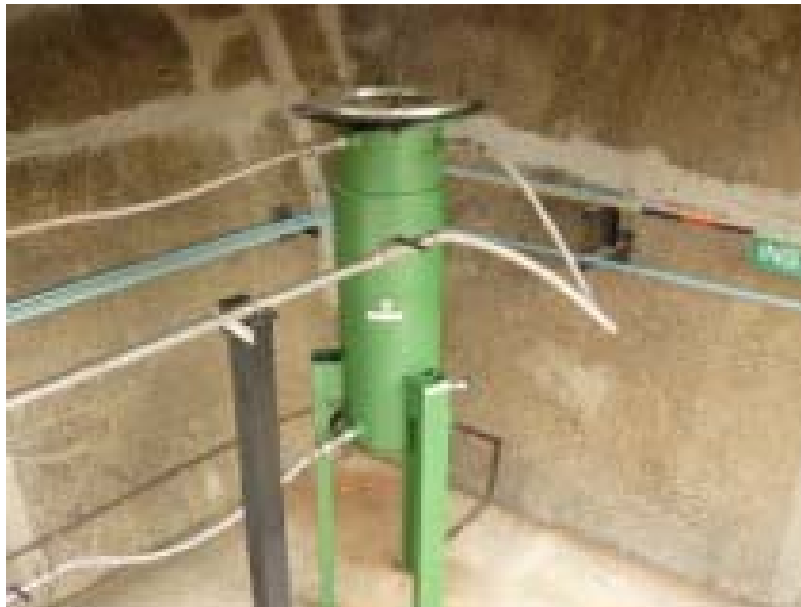
The Test Pot

- 5.1.3 After a full set of testing, the conveyor belting used to protect the steel pot is quite severely damaged and needs to be replaced.
- 5.1.4 During trials, the Coriolis mass flowmeter has stuck twice, allowing more methane into the system than the instrumentation indicates. This needs to be rectified by the suppliers.

- 6.1.1 The Gallery has worked successfully during commissioning.
- 6.1.2 The safety procedures and safety equipment appear to be adequate for the task at hand.
- 6.1.3 The conveyor belting inside the Test Pot needs to be replaced after each set of tests have been completed.
- 6.1.4 Hazard studies four five and six need to be conducted.
